Westford Fire Dept. Headquarters

Westford Fire Dept. - Agenda

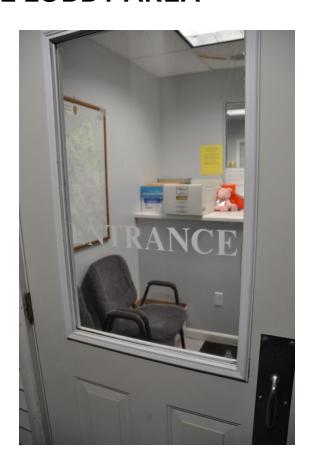
THE LOBBY AREA

- Unable to accommodate meetings with the public and other town departments
- Unable to accommodate Fire Prevention functions
- No separate boiler or electrical rooms
- The building is in disrepair and in need of major repairs and updating
- The lobby area is 6' by 5' and not conducive to good customer service

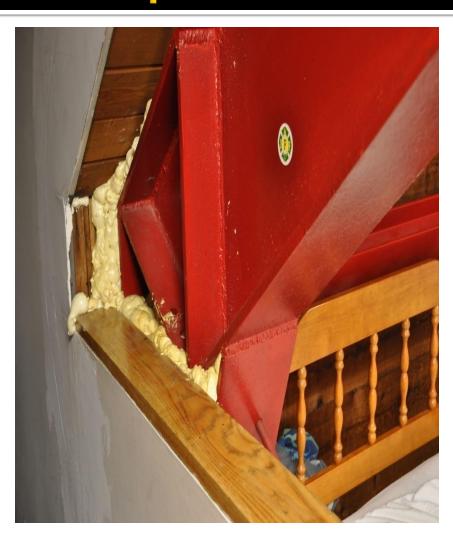
This shows the dormitory area that was leaking water.

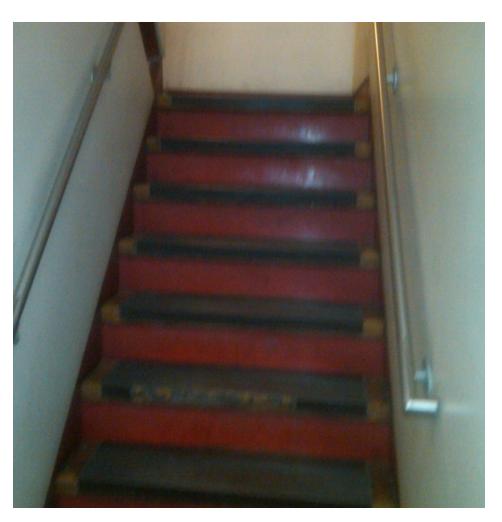
Not ADA compliant, no elevator in the building. 2, twenty eight step stairways to the second floor administrative offices.

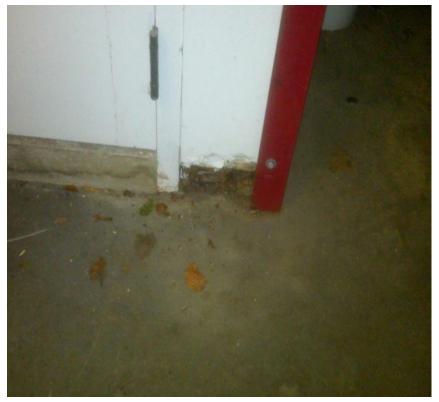
ROT ON WALL NEAR THE WASH AREA

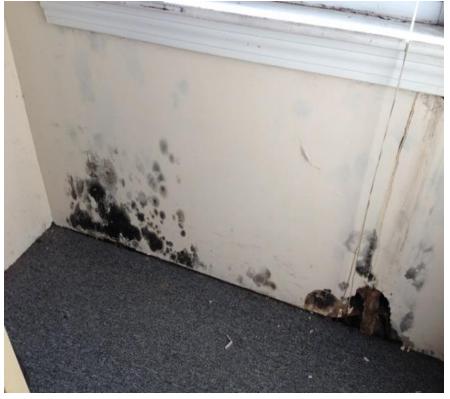
THIS SHOWS ROT AND WATER DAMAGE, RISK OF MOLD DAMAGE

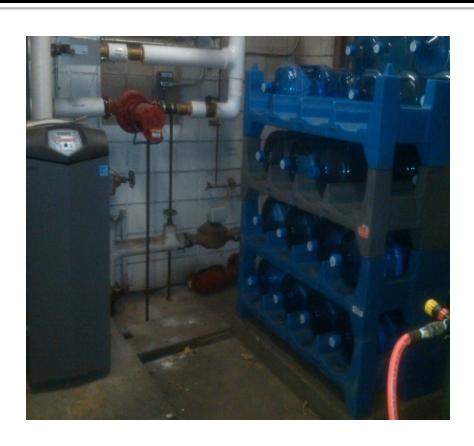
The boiler/electrical room now stores our spring water. It also houses our Bio-Hazard storage

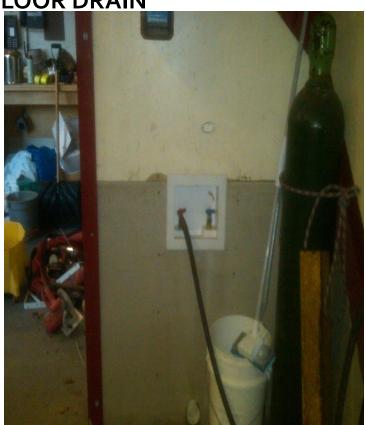
PRESENT DECON AREA IS A
GARDEN HOSE WITH HOT AND
COLD WATER RUNNING DOWN A
FLOOR DRAIN

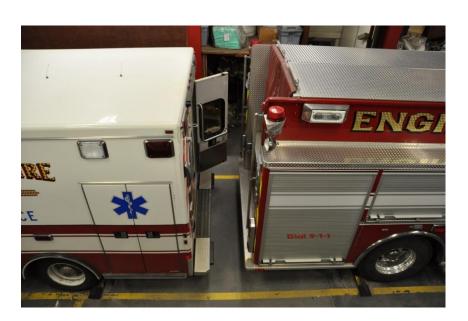
W-12 AND E-1

- Apparatus
 - Not all vehicles are inside, which will shorten the life expectancy of the vehicle driving up the cost for early replacement
- Employee safety on apparatus floor
 - Less than two feet between the vehicles and the doors, making hard to get the stretchers out of the ambulances for cleaning and maintenance
 - Makes for a safer working environment when all equipment has a spot to be stored

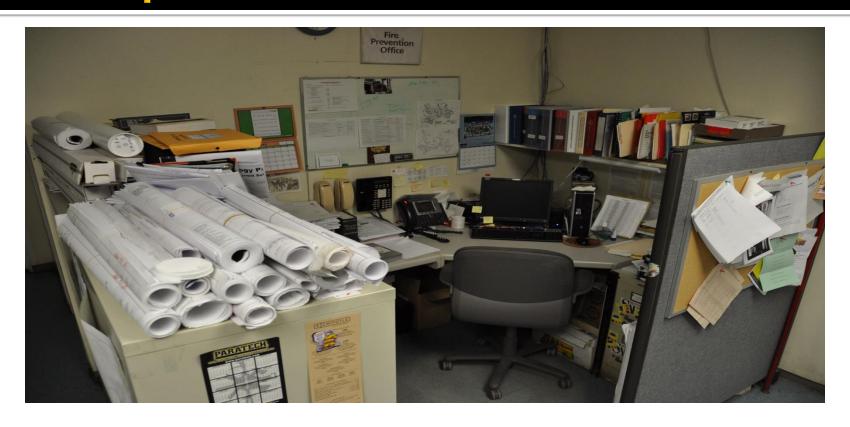
The fire prevention office is an employee built space with limited desk space and open to the day room with no doors, no privacy. Approx. 6X8

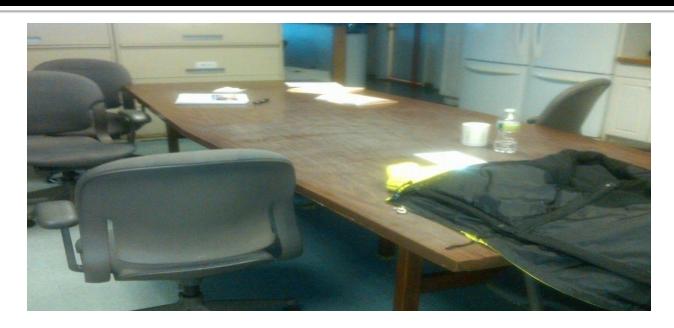
This is our kitchen table that is used for meetings with the public. This does not promote good business practice.
